New York State Department of Transportation

Yellow Flag NB2228W011

BIN: 1065318

Feature Carried: 278I278IX2M23027

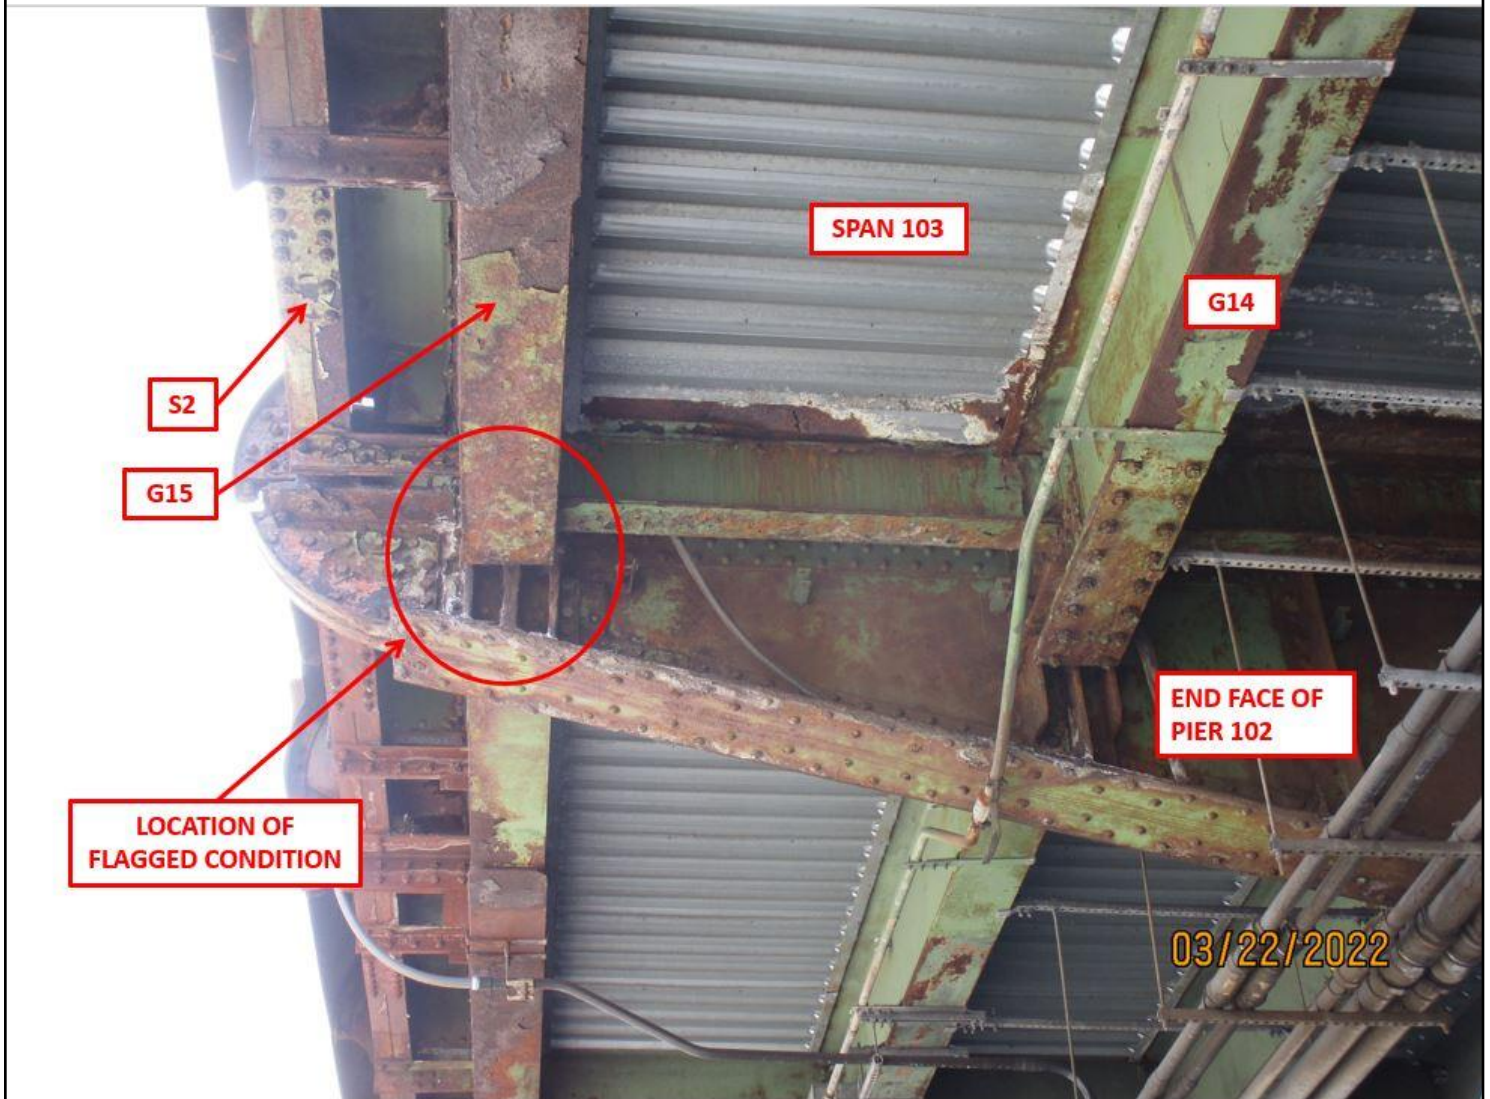
Photo Number: 1

Description: The expansion bearing under Girder G15 on Span 103 side of Pier 102 is not functioning as designed. Although the bearing plate is presently flush with the pedestal at both sides of the bearing at 55 degree F, the bearing plate was previously noted in the last inspection to be overhanging the pedestal for 1/2" at both sides of the bearing at a temperature of 56 degree F. Additionally, the sliding bearing plate is loose and moves when the inspection team hammers at the bearing plate (same as the previous inspection). The front keeper plate at the bearing is missing.

The bearing exhibits moderate to heavy corrosion with up to 15% section loss.

Attachment Description: General view of the flagged condition at the bearing under Girder G15 on Span 103 side of Pier 102. Looking Begin.

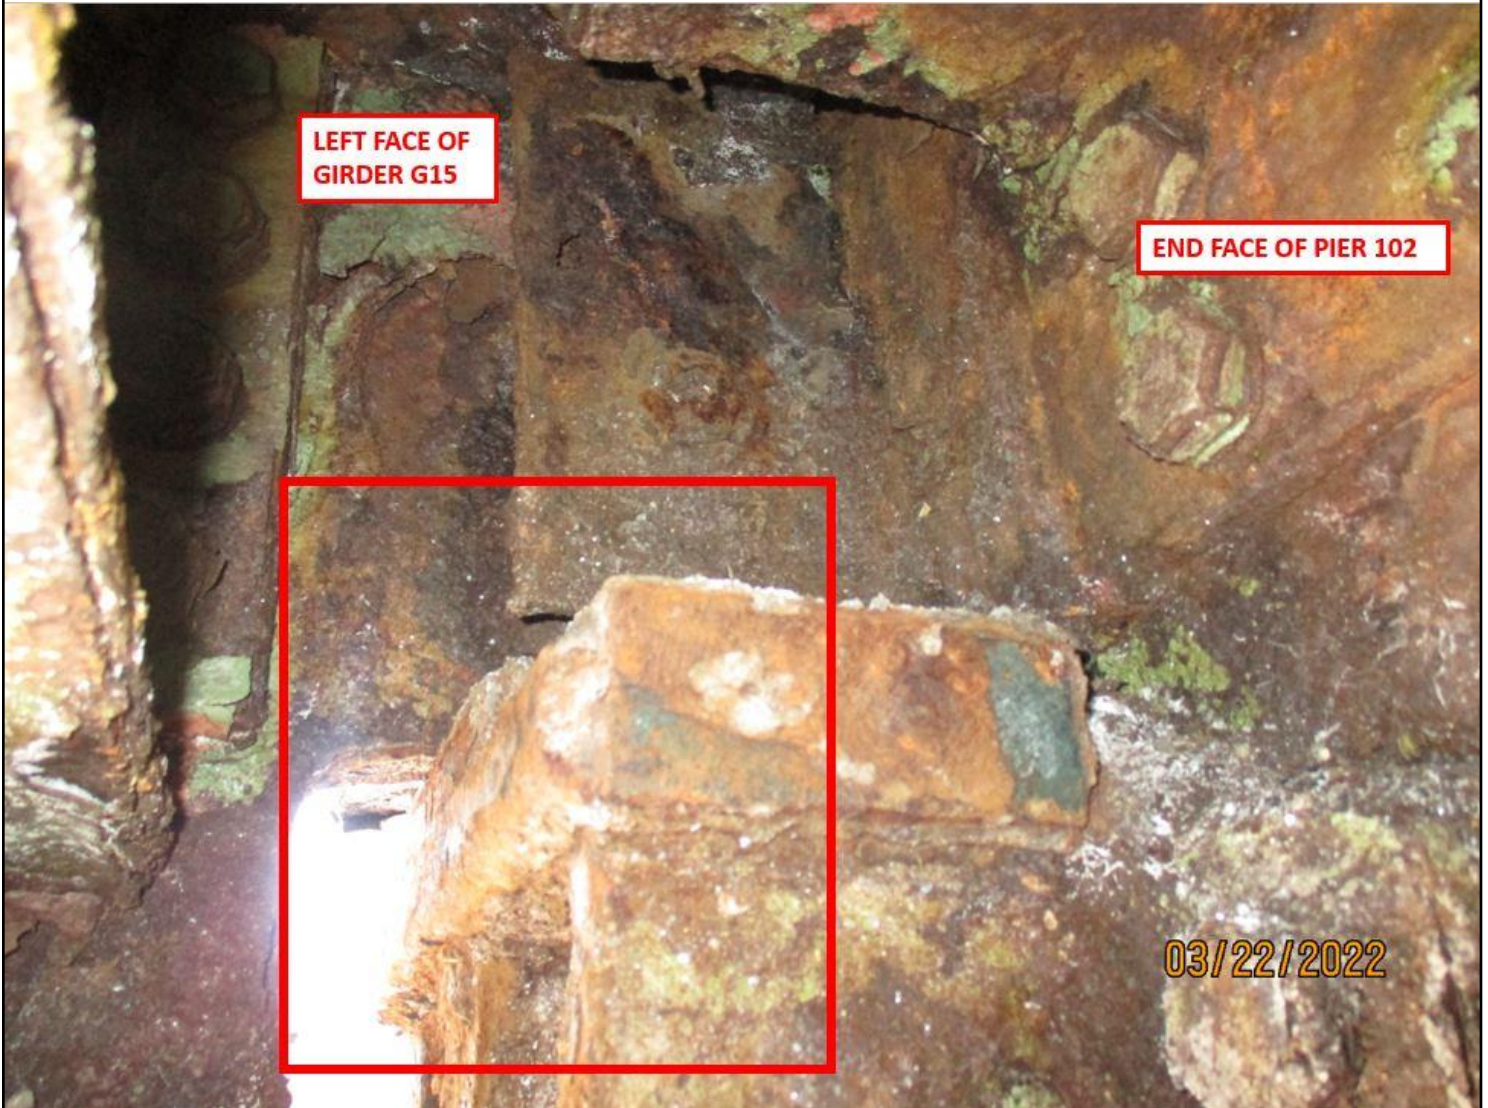
Photo Number: 2

- 2.The left guide angle exhibits up to 50% section loss with 1" diameter hole. The keeper plates at both sides of the bearing exhibit corrosion but in generally good condition. Both guide angle bolts are broken or missing (no change from the previous).

Attachment Description: The left face of the bearing under Girder G15 on Span 103 side at Pier 102. The bearing plate is loose and is flush with the pedestal with the front keeper plate missing. Looking Right.

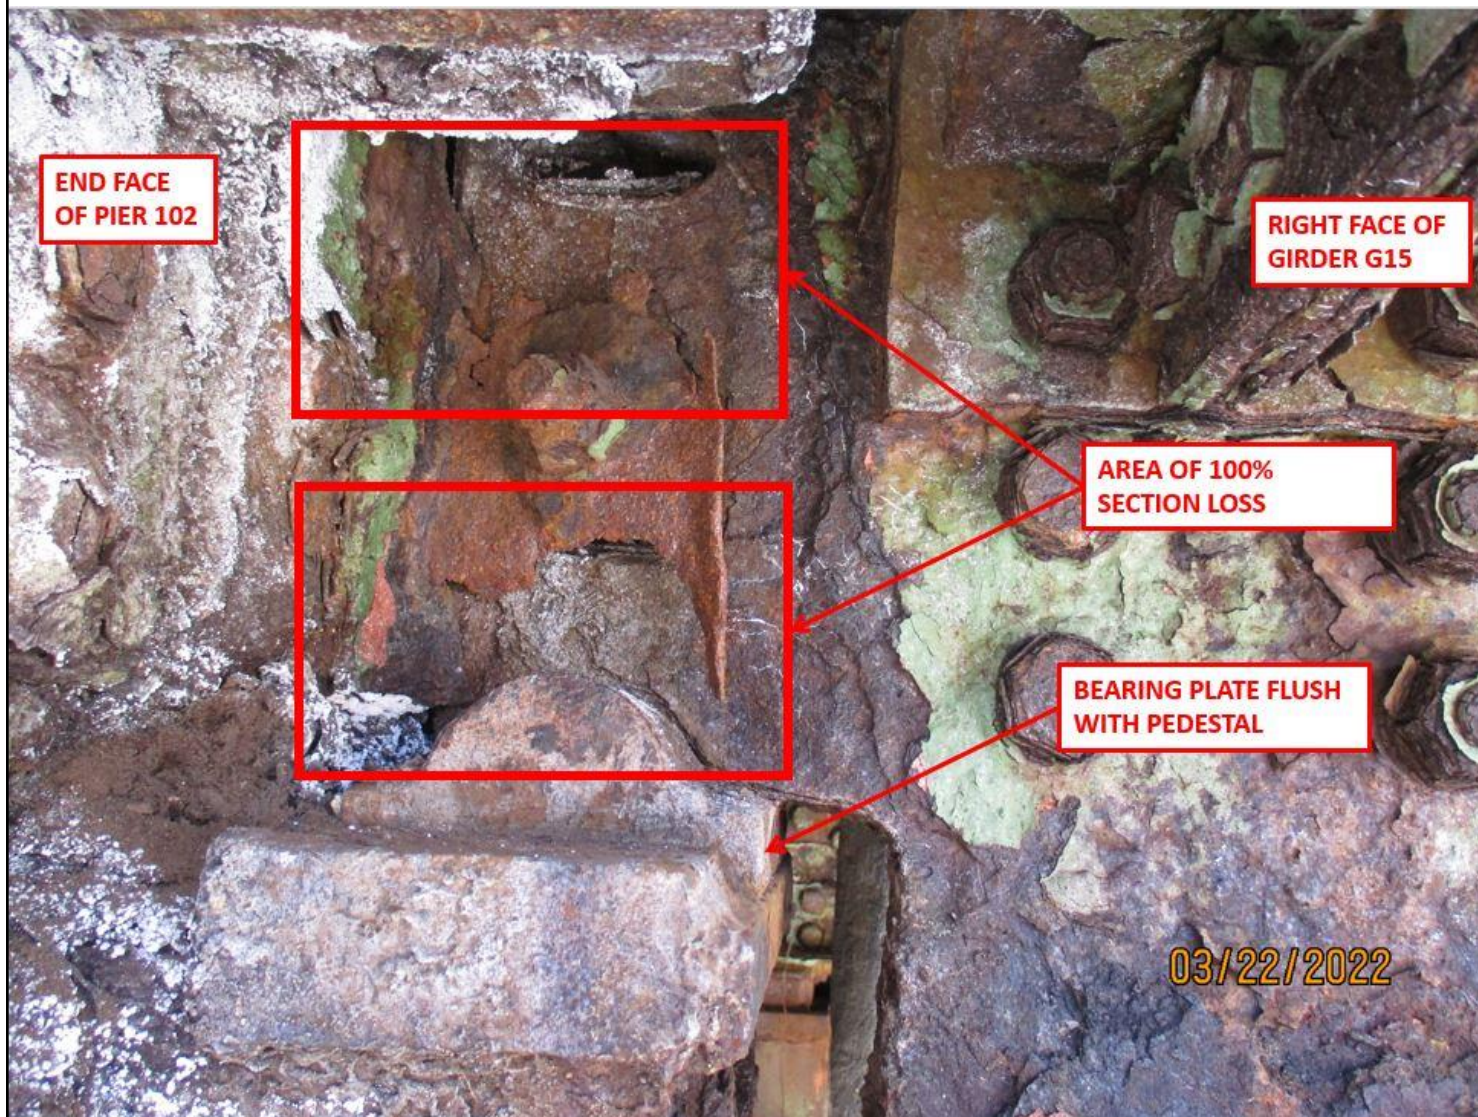
Photo Number: 3

- 1.The right guide angle exhibits area of 100% section loss at the top for 5" x 5" and at the bottom for 4" x 2" (no change from the previous inspection).

Attachment Description: The right face of the bearing under Girder G15 on Span 103 side at Pier 102. The bearing plate is loose and is flush with the pedestal with areas of 100% section loss at the right guide angle. Looking Left.
